Final Report

15 Nov 94 - 14 May 99

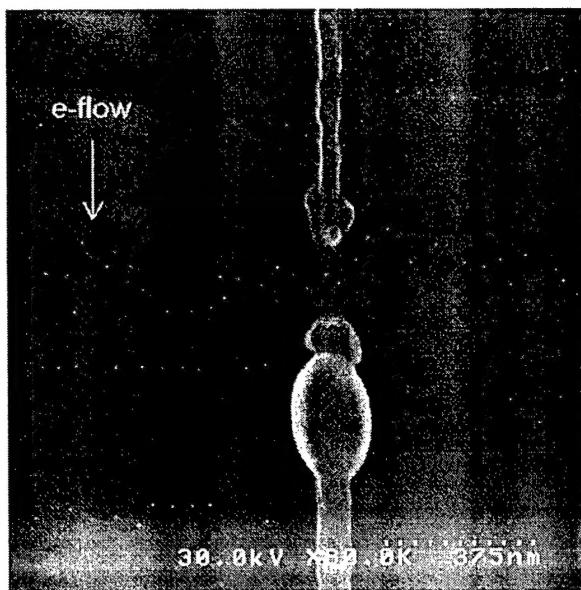
Examination of the postmortem samples by FESEM revealed several unique EM features for these sub-tenth-micrometer lines, different from what is usually observed in wider unpassivated test lines. First, only a small portion of the lines failed inside the lines themselves, as shown in Figure 4, and most of the failures that we could detect were due to loss of material at the joint area between the lines and their upwind e-beam pads, within the e-beam pads of the sub-tenth-micrometer lines, indicating the actual lifetimes for these lines should be longer than the test results, which is already two orders longer than that of control samples. Figure 5 shows a typical failure at the joint. No early failure sites within the lines could be found, even with the FESEM at magnifications approaching 500 kX. We believe that our inability to detect the early failures in the lines with no pad degradation was due to the existence of the native oxide overlayer, and the extremely small amount of material required to be removed to create an open circuit between grain boundaries. In some cases, a large amount of material was transported away from the upwind pads before failure took place, yet we did not find any hillocks in the downwind pads, and the bumps in some of the lines are not big enough to accommodate so much material. In two test structures, open circuit failure took place even inside the e-beam pads.

Figure 4. Failure within a 60 nm line. It is believed the front was damaged by an electric arc at the final stage. A narrowed segment and bump also can be clearly seen.

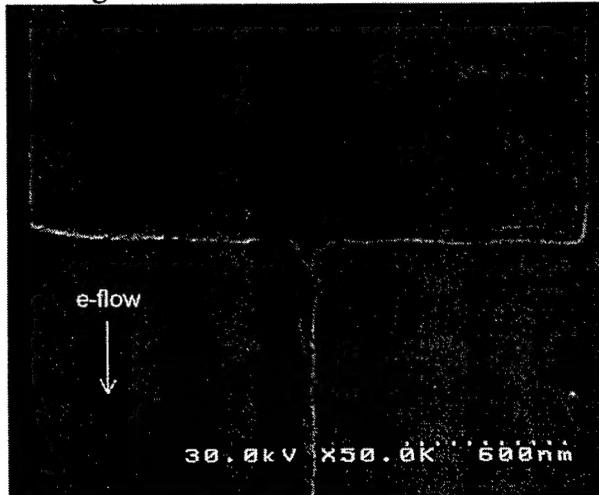
Figure 5. Failure at the joint of a 60 nm line and its e-beam pad.

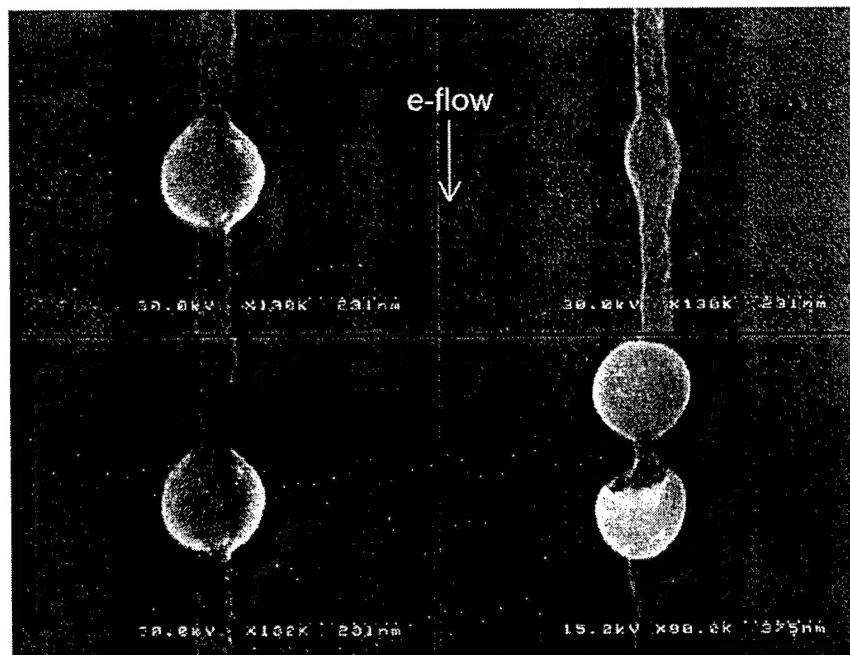
In some lines, bumps of various shapes, primarily spindle or spherical, developed in random segments in the lines. Some lines do not have bumps at all, some have single, or multiple, or two next to each other, as shown in Figure 6.

Figure 6. Various shapes of the bumps found in the tested lines.

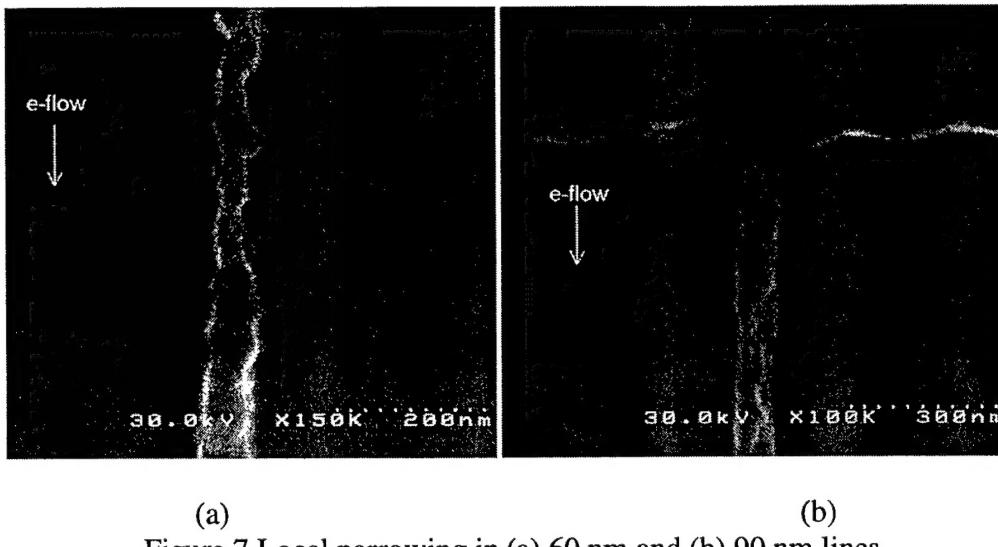
Another interesting point is that some lines exhibited microstructural changes. Some segments became narrower and bamboo grain structures developed during stress. Figure 7(a) and 7(b) show the narrowed segments and bamboo grain structures. Some segments narrowed down to less than 30 nm. Since it took some time for the structures to develop, we believe the early failures were not within these lines, so the lifetimes of these narrowed lines were at least at the order of hundreds of hours under the aforementioned stress conditions, which were remarkably high.

Figure 7 Local narrowing in (a) 60 nm and (b) 90 nm lines

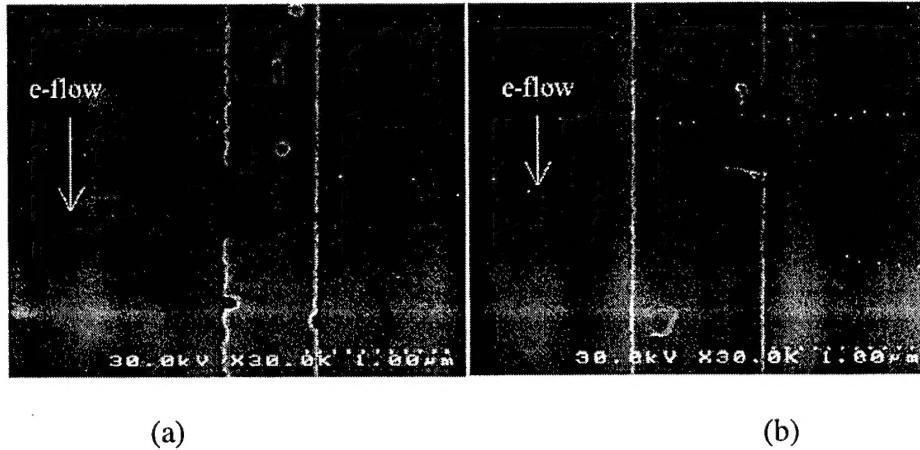
Control samples of 600 nm and 900 nm width were fabricated and stressed under the same conditions as for the sub-tenth-micrometer lines. The lifetime measurement data of 600 nm and 900 nm wide fit the lognormal distribution very well. Their lifetimes were in the range of 10 hours, i.e. more than two orders of magnitude shorter than that for the narrow samples, whose lifetimes could be still higher should their e-beam pads have not failed prior to the lines. We also observed voids in upwind lines and hillocks in downwind lines and e-beam pads, as shown in Figure 8, which were common in the literature.

Figure 8. Failure sites in control samples of 600 nm and 900 nm width. Void and hillock developments are common in the literature.

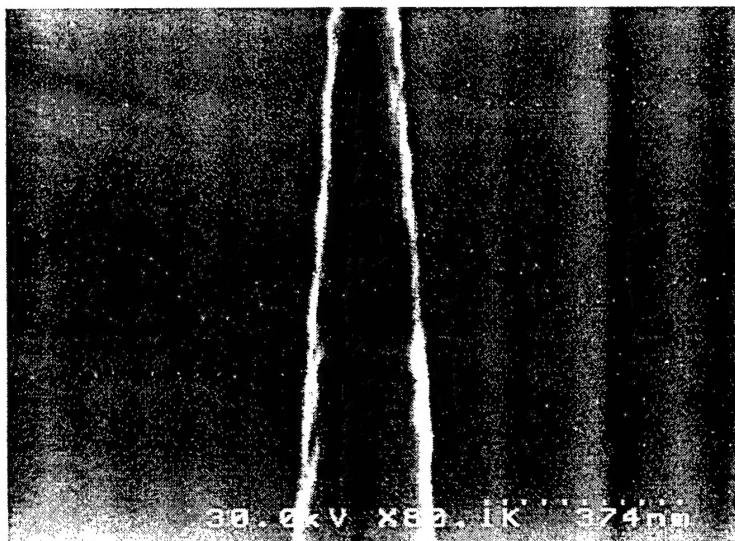
Upon examination of the failure sites, it was found that the sites were always damaged, probably by arcing, similar to that shown in Figure 4. Voids were never found within the lines. There is a possible explanation for the damage where voids are expected. In the wide lines, where voids commonly form due to EM damage, at the final stage of EM, current is concentrated into a very small cross-sectional area, catastrophic damage occurs and the relatively large volume of metal at both sides of the void can be a good heat sink and conduct the heat away in time, leaving a voided open circuit failure. But in the very narrow lines, current density is very high, while the line does not have good dissipation of the heat generated at the final catastrophic stage, resulting in arcing damage at the moment of the open circuit occurs. At present, we don't have direct evidence of what actually happens at the failure sites. Direct *insitu* observation will help to get more information about it. This is part of the future work. Hillocks also grew in the lines, mostly in the form of spheres and spindles, some of which are larger than the linewidth, and

Figure 10 EM Failure in one of the triangular pads

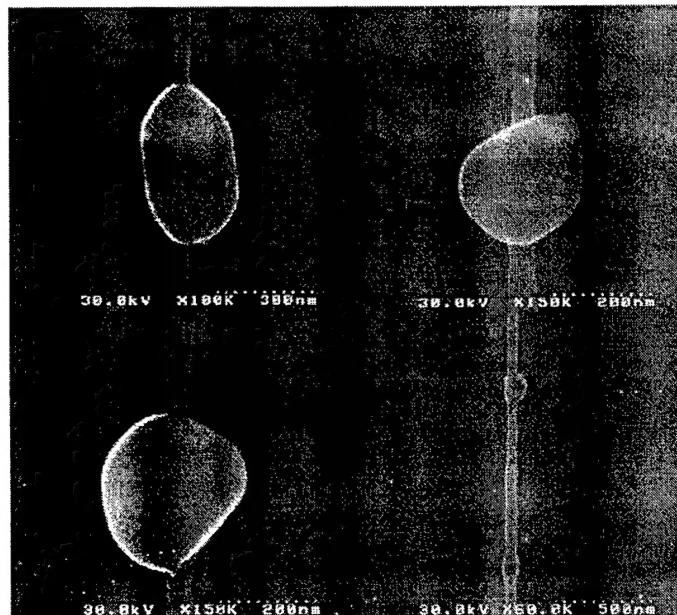
some have irregular shapes. Figure 11 shows some typical ones. The mechanisms for the formation and growth of these bump-shaped hillocks are as yet unclear. In an *insitu* experiment, bumps were observed to grow very fast only over a short period, and then grow very slowly or stop growing at all, and they were not the cause of line failures. Bump growth happened at all

Figure 11 Some irregular-shaped bumps in 40 nm and 50 nm lines

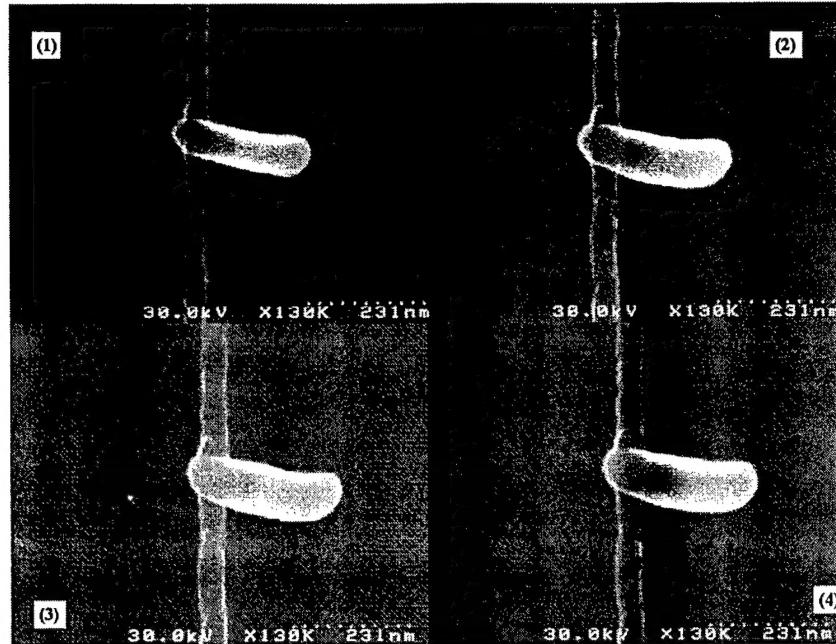
stages of stressing, not being restricted to any certain period. One series of the hillock growth is shown in Figure 12. It is obvious that an unstable situation developed in some segment of the test line and induced the bump formation and growth. With the growth of the bump, the instability factor gradually disappeared and growth stopped. An interesting aspect to notice is that, after the bumps stop growing, while we believe EM is still underway, the mass flow through the bump is at a balance. Intuitively, at big bumps, current density is lower than both sides of the lines, and mass flow divergence should occur which leads to material accumulation at the upwind side of the bump and material depletion at the downwind side. So once a bump starts to grow, one would expect this unbalanced process to develop, but in reality, this did not happen. More work will be done on it, including *insitu* studies, in order to better understand the underlying mechanisms.

Figure 12 *In situ* observation of bump growth:
 (1) After 22 hr; (2) After 35 hr; (3) After 54 hr; (4) After 59 hr
